Technical bulletin

TB-040

Charging system Isuzu / Opel / Vauxhall

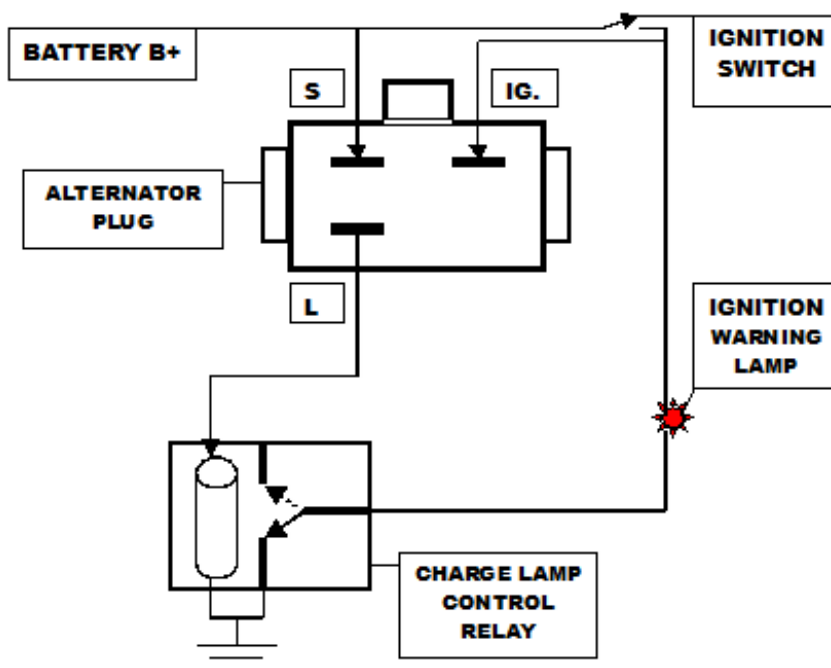
The charging system on most Isuzu, Opel and Vauxhall applications fitted with these alternators have a charge relay fitted in the circuit. One of the functions of the relay is to control the charge warning lamp. When the original alternator fails, it is possible for excessive voltage to be produced on the 'L' terminal, this high voltage can overheat/burnout the relay coil. The relay must be checked for serviceability before installing the replacement alternator. Failure to do so could prevent the replacement alternator from charging.

NOTE. The ignition circuit is used to excite the alternator, not the lamp circuit.
