Technical bulletin

TB-041

Charging system Isuzu / Opel / Vauxhall

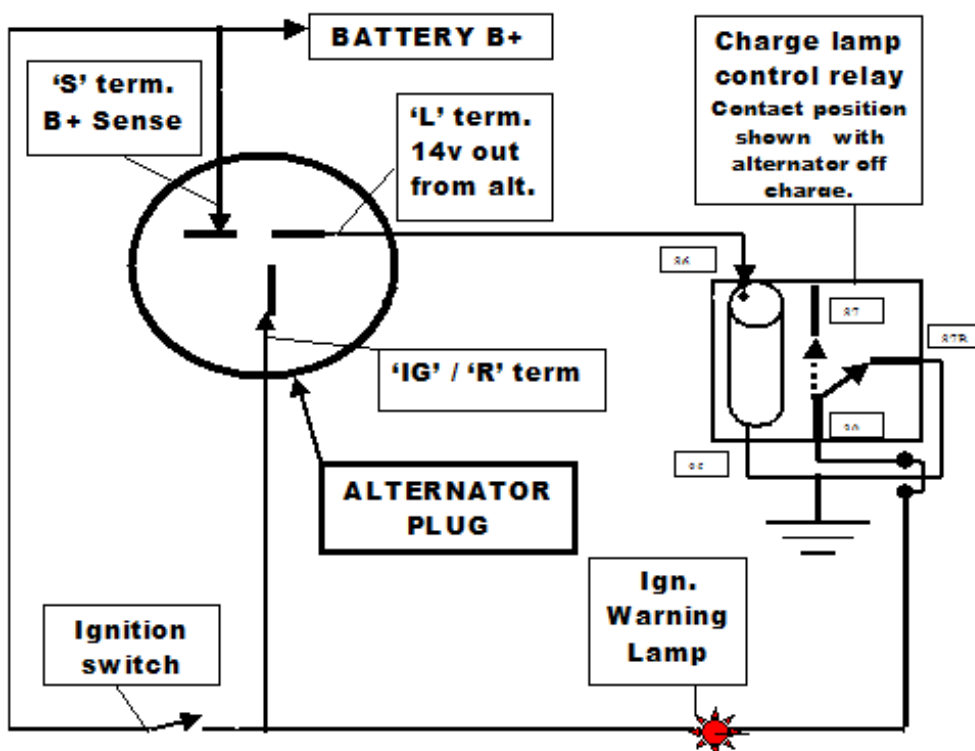
The charging system on most Isuzu, Opel and Vauxhall applications fitted with these alternators have a charge relay fitted in the circuit. One of the functions of this relay is to control the charging warning lamp. When the original alternator fails, it is possible for excessive voltage to be produced at the 'L' terminal, this high voltage can overheat/burnout the relay coil. The relay must be checked for serviceability before installing the replacement alternator. Failure to do so could prevent the replacement alternator from charging.

NOTE. The ignition supply is used to excite the alternator not the lamp circuit. Circuit above shows approximate correct operating voltages.
