Technical bulletin

TB-074

Important Notification

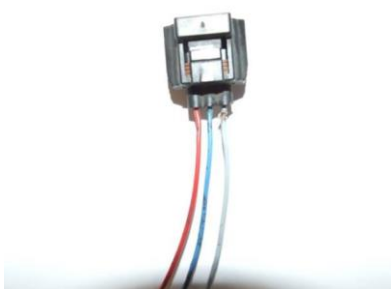
After fitting this new alternator the warning light can stay on. This can be caused by the red wire linked to the sense terminal (A) being broken. If the sense terminal connection is interrupted there will be no connection to the PCM (Power Control Module) and the warning light won't switch off.
