## **Technical bulletin**

TB-039

## Charging system Isusu / Opel / Vauxhall

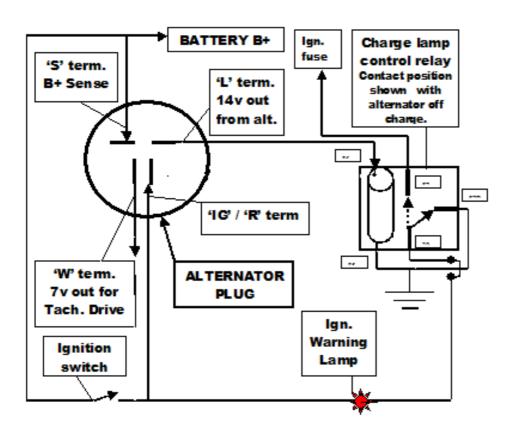
The charging system on most Isuzu, Opel and Vauxhall applications fitted with these alternators have a charge relay fitted in the circuit. One of the functions of this relay is to control the charging warning lamp. When the original alternator fails, it is possible for excessive voltage to be produced at the 'L' terminal, this high voltage can overheat/burnout the relay coil. The relay must be checked for serviceability before installing the replacement alternator. Failure to do so could prevent the replacement alternator from charging.

NOTE. The ignition supply is used to excite the alternator not the lamp circuit. Circuit above shows approximate correct operating voltages.
