## Technical bulletin

## TB-052

### Application: Ford 2.0 & 2.4 Diesel

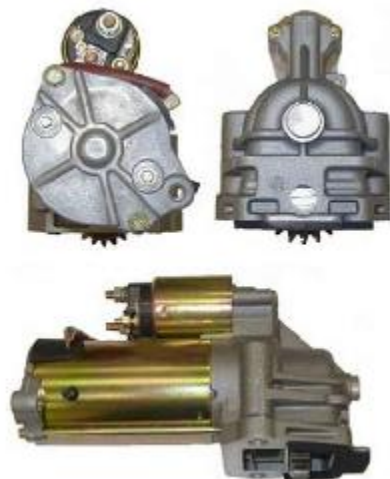
This application suffers from excessive steel-dust contamination.

Excessive amounts of ferrous dust can be produced by the gradual degradation of the Dual-Mass Flywheel. This can cause the starter to fail by contaminating the motor magnets and the pinion shaft. Common symptoms are solenoid clicking but not engaging, or intermittent starter operation. If this replacement starter motor is installed without rectifying the cause of the dust, it will become contaminated and fail in a very short time.

Your warranty on this replacement starter motor will be void if the starter is found to be contaminated with steel dust.
