## Technical bulletin

## TB-085

### ATTENTION!

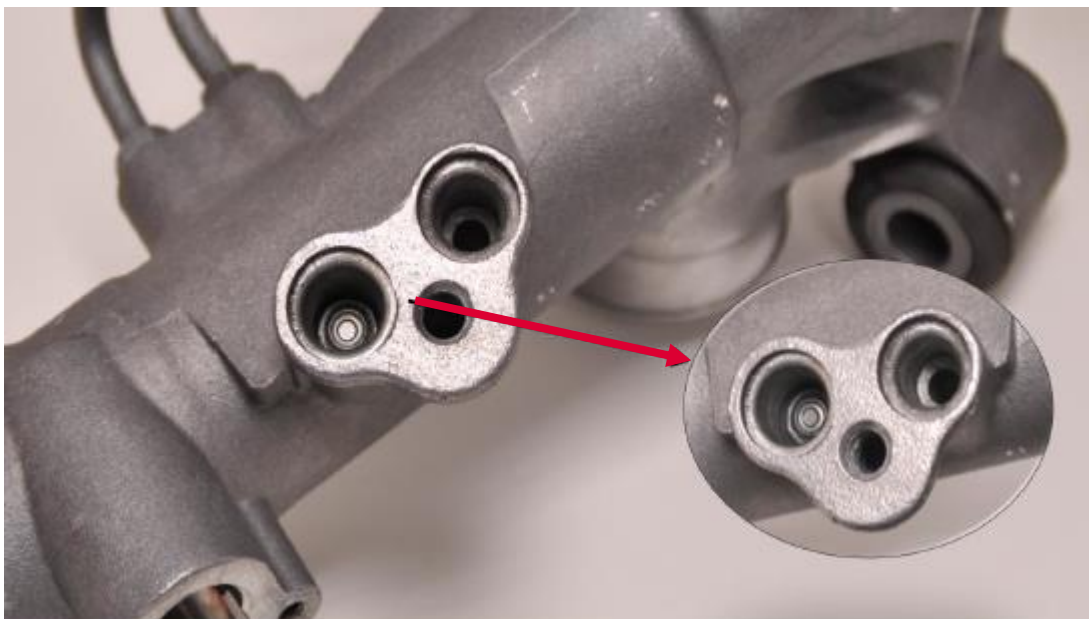
This Technical Bulletin is for power steering racks fitted with a NON RETURN VALVE (See picture).

Please ensure that the one way valve is present within this steering rack port before fitting your replacement rack to the vehicle.

Should the valve be missing, remove (Note the position) and clean the original from the old unit, taking care not to damage the valve or port.

When re-fitting the valve to your replacement rack, ensure that the valve is free from damage and that it placed into the correct port.

Failure to do so could cause damage to the steering rack and may invalidate your warranty.
