Technical bulletin

TB-003

ATTENTION!

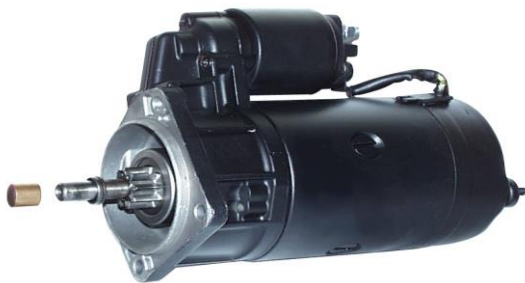
Replace the pinion bush on the vehicle before installing the starter motor, severe bearing damage can be caused by a worn bush.

The starter motor is designed with an external shaft support bush which fits in the bell-housing or engine backplate.

A common cause of failure is excessive wear to the inner diameter of the bush, which can cause premature failure of the starter motor.

It is vitally important to fit a new bush that is supplied with this replacement starter motor.

Use a tap from a tap and die set, this will cut a thread in the soft copper bush and it gradually twist it out.

It's good practice to soak the new bush in oil before fitment. The new bush is delicate, so be sure not to damage it during fitment. Use soft tools to fit the new bush.
